**Slope Stability Evaluation
Ground Anchor Construction Area
White Point Landslide
San Pedro District
Los Angeles, California**

July 1, 2014

**RE: SLOPE STABILITY EVALUATION, GROUND ANCHOR CONSTRUCTION
AREA, WHITE POINT LANDSLIDE, SAN PEDRO DISTRICT,
LOS ANGELES, CALIFORNIA**

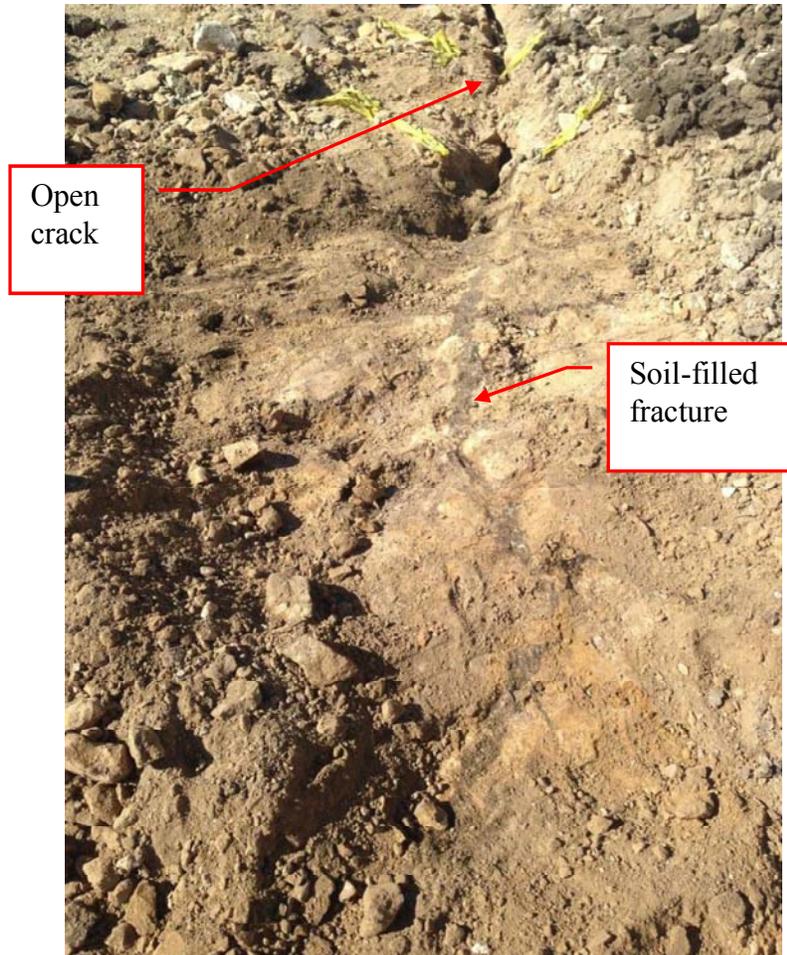
On October 28, 2013 following the excavation of the construction bench, Nancy Smith of HBI noted a linear crack or fracture approximately 6 feet in length and 2 to 3 inches in width that trended across the construction bench. Shannon & Wilson visited the site on the same day to measure and record the location and width of the fracture (FAR 1). During our initial observations (FARs 1 through 6), we measured the open portion of the crack, which was approximately 9 feet long and 0.5- to 1.5-inches wide. A portion of the crack was soil-filled and extended approximately 18 feet from the east end of the open crack, where it was obscured by surficial materials, as shown in Photograph 1 below.

Photograph 1 – View to the west of the open crack on the construction bench.

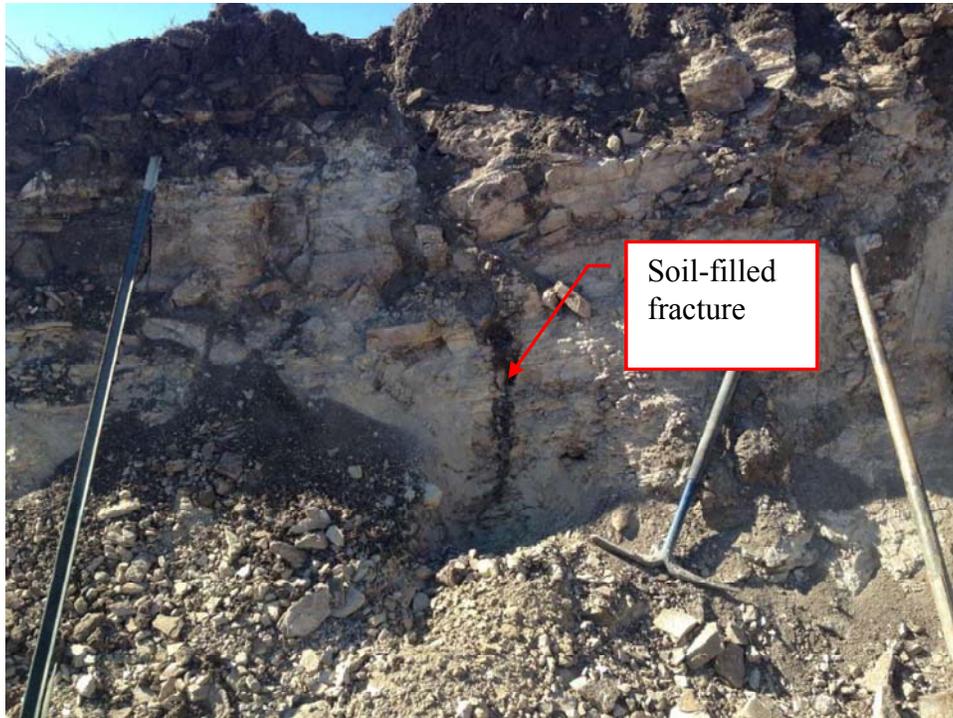
A soil-filled portion of the crack was present on the western wall of the construction bench excavation as shown in Photograph 2.

**Photograph 2 - Soil-filled fracture in the western cut for the construction bench.
The view is looking west with the construction bench access slope
to the right of the photograph and the ocean to the left.**
