Vegetation Assessment Report

PROJECT: **OROVISTA AVENUE NORTH OF BIG TUJUNGA CANYON ROAD
(W.O. E6000347)**

Prepared by: William Jones, Environmental Supervisor I
Bureau of Engineering,
Environmental Management Group (EMG).

Report Date: May 23, 2013

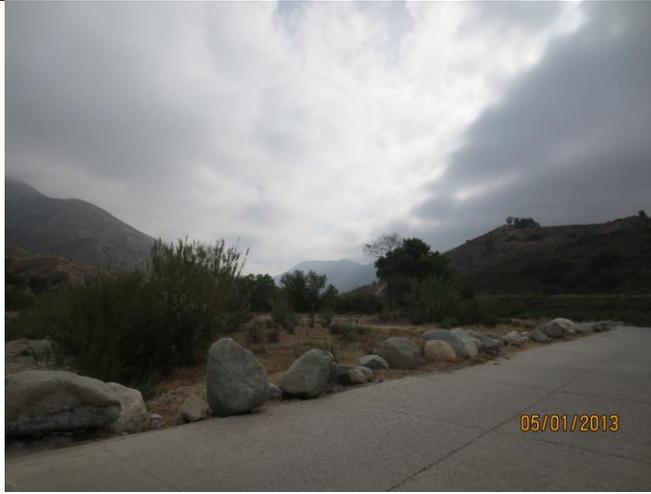
Photo 1

1. **Across Oro Vista Avenue, looking northeast.**

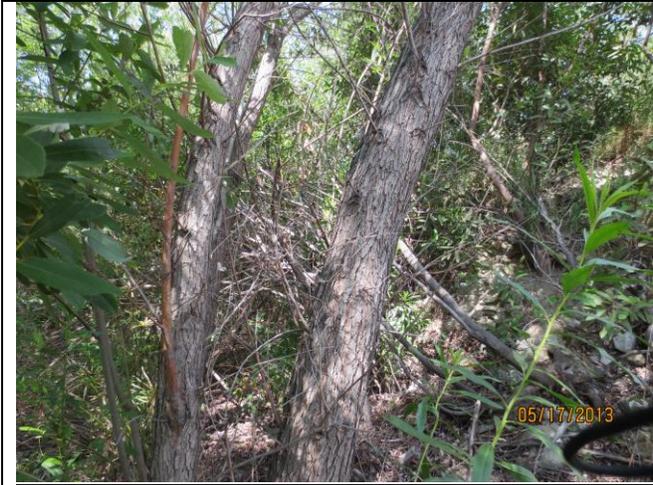
Photo 2

Within the ephemeral stream channel, dominant species include several willow species-shinning or yellow willow (*Salix lucida* Muhl.) (Photo 2), arroyo willow (*S. Lasiolepis* Benth.), and narrow-leaf willow (*S. exigua* Nutt.) (Photo 3). Other tree species included Fremont and black cottonwood (*Populus fremontii* S. Wats.) and (*P. balsamifera* L. var. *trichocarpa*: Torr. & A. Gray) Brayshaw. Other common, native shrub species included California sagebrush, (*Artemisia californica* Less.), wishbone bush (*Mirabilis laevis* (Benth.) Curran), laurel sumac (*Malosma laurina* (Nutt.) Abrams), buckwheat (*Eriogonum fasciculatum* Benth.), coast goldenbush (*Isocoma menziesii* (Hook. Arn.) Neesom), and mule fat (*Baccharis salicifolia* (Ruiz Lopez and Pavon) Pers.). Common native, annual herbaceous species included yellow pincushion (*Chaenactis glabriuscula* var. *megacephala* A. Gray) (Photo 4), foothill poppy (*Eschscholzia caespitosa* Nutt.) (Photo 5) and stinging lupine (*Lupinus hirsutissimus* Benth.) (Photo 6).

3. Replace removed, native trees greater than 7.5 centimeters (three inches) in diameter. Removed trees shall be replaced with the same species on a three-for-one basis. One native tree species – golden (or shining) willow (*Salix lucida* Mulenb.) - is involved. Since two trees are to be removed, six replacement trees will be required mitigation.

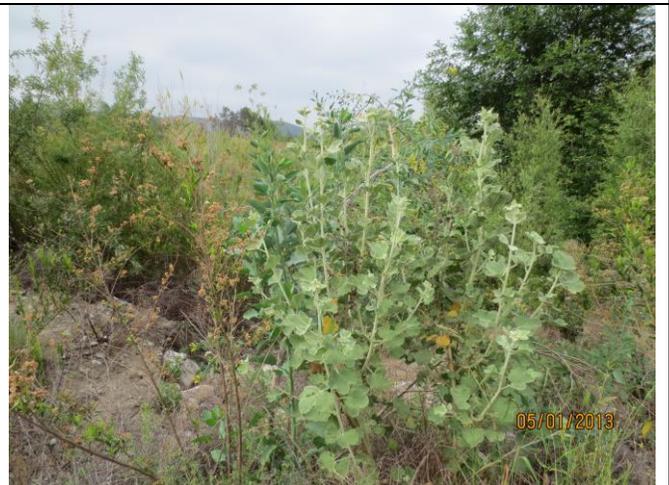
Photo 7

One rare shrub species- Davidson's Bush Mallow (*Malacothamnus davidsonii* ((Robinson) E. Greene) - was recorded just upstream from the culvert inlets at Oro Vista Avenue (Photo 7). Several individuals are present. All morphological characters align with *M. davidsonii*, except that the stellate hairs are white, instead of yellow. The species is listed (1B.2) in the California Native Plant Society's state inventory of native, rare and endangered vascular plant species.
