Phase I Environmental Site Assessment

Project: North Outfall Sewer—East Central Interceptor Sewer
Mission Road at Jesse Street

Study By: City of Los Angeles
Bureau of Engineering
Environmental Group

Date: March 27, 2000

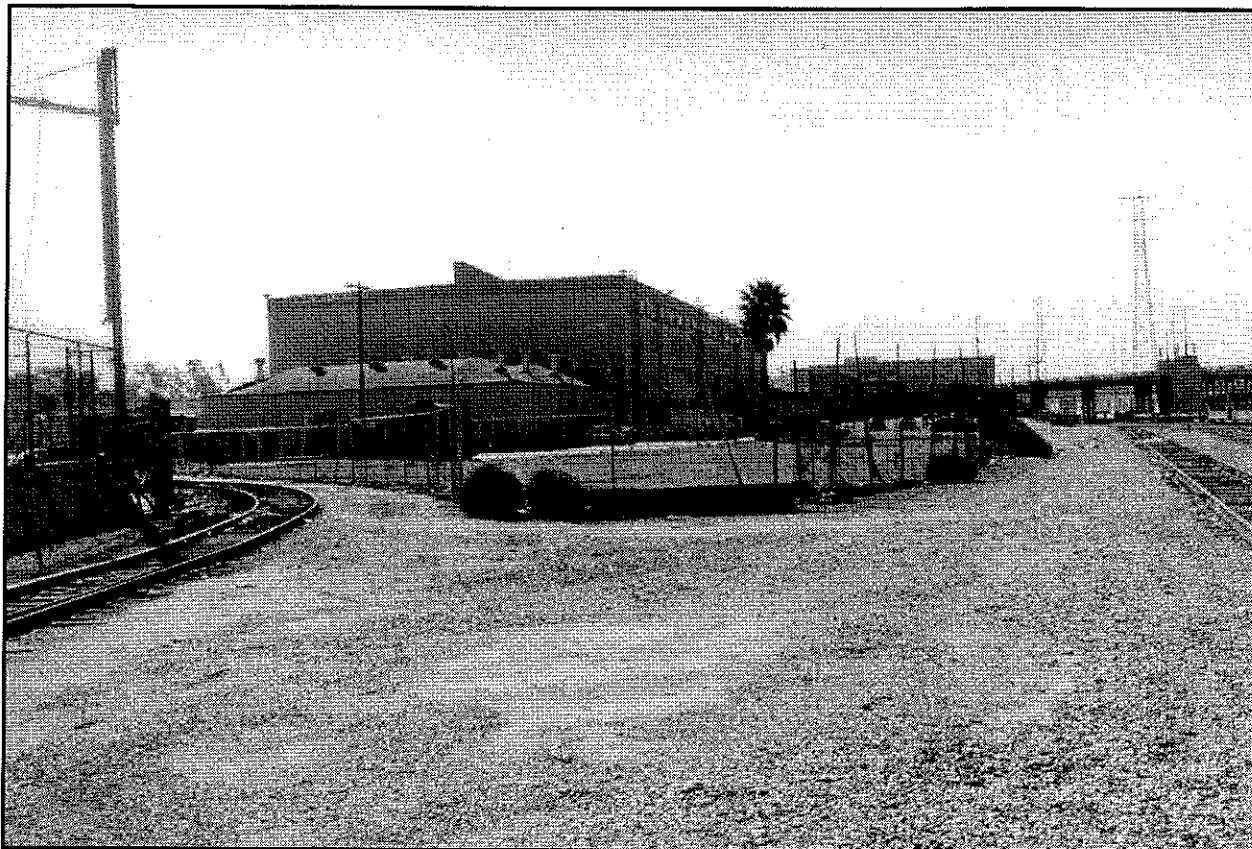
FIGURE 3. Photograph of the Triangular Parcel.

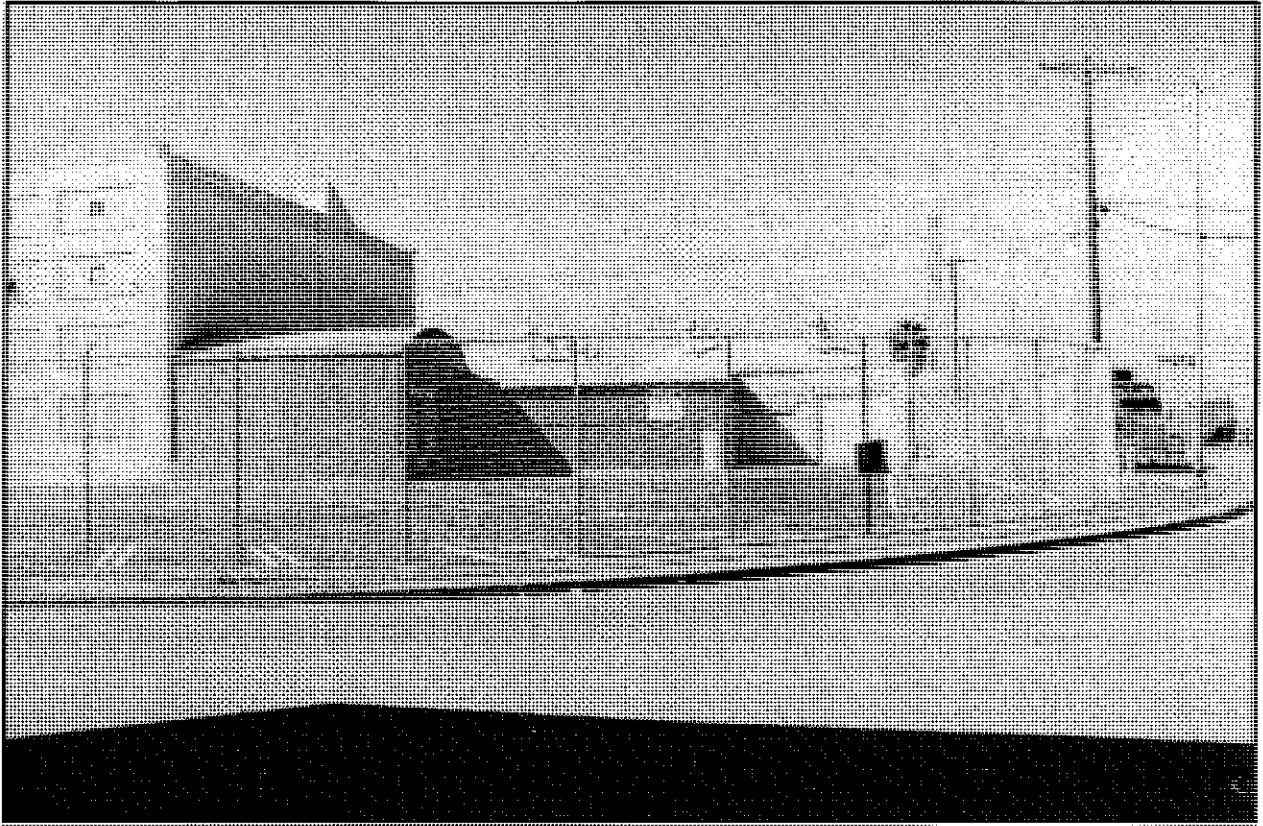
FIGURE 4. Photograph of buildings occupying Lots A through D.

Thus, to better characterize conditions, EG urges thorough onsite assessment of the Site by a qualified environmental assessor. Because EG did not gain full access to all properties, particularly the warehouse properties, EG performed a "long distance"

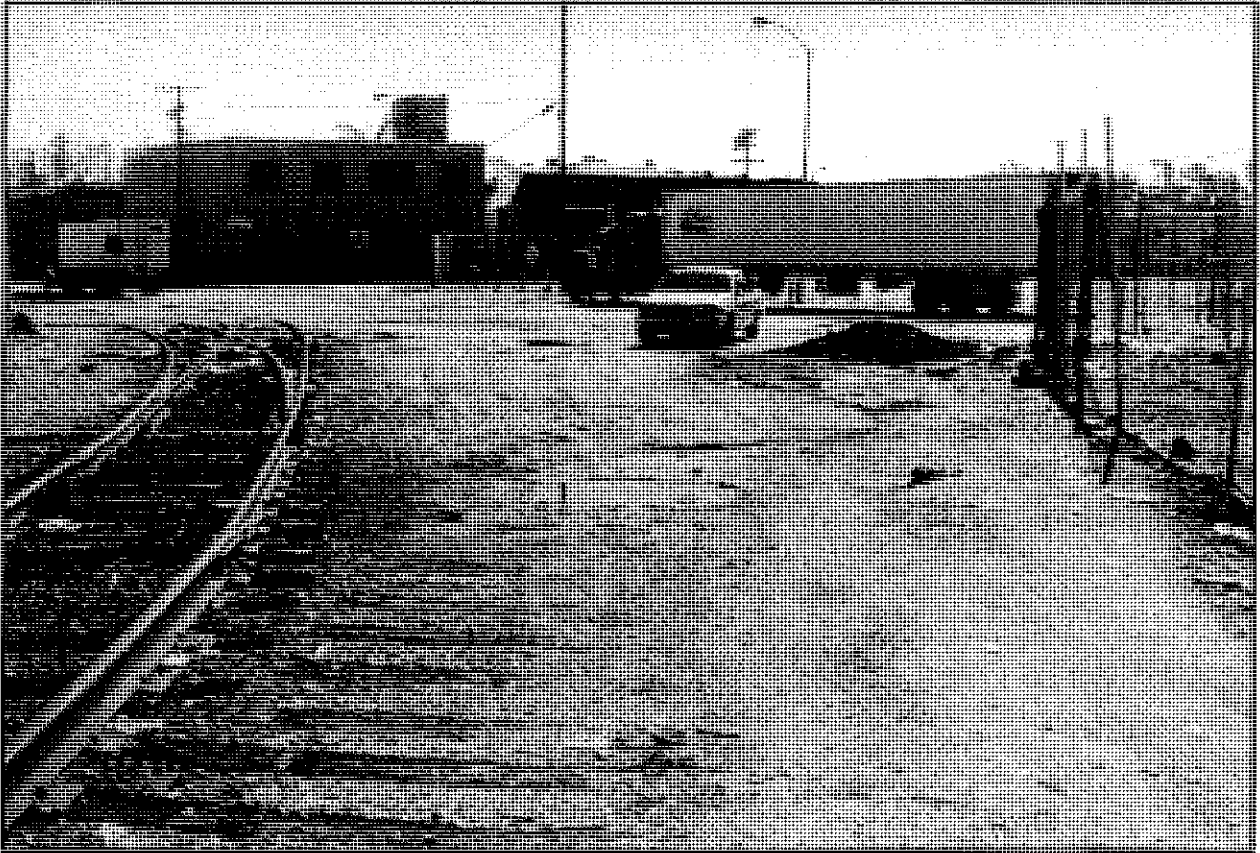
Of particular concern, EG observed railroad ties and isolated railroad tracks chronicling a former rail spur that crossed the Site. Figure 6 shows the location and remains of part of this spur. Although EG noted no particular chemical impacts, railroad uses commonly cause negative environmental impacts to soil and groundwater.

FIGURE 6. Remains of railroad spur on Triangular Parcel and continuing on Lot C (behind tractor-trailer rig).

EG recommends a Phase II investigation of the Site. At least one sampling event should attempt to determine whether the chemicals apparently spilled at the railroad spur adjacent to the food processing plant at 633 Mission Road may have impacted the Site adversely. The predominance of current and former railroad and industrial uses in the vicinity and the associated risk of environmental impact—particularly from former hazardous materials handling and storage facilities at which no known environmental investigation occurred—further warrant sampling at the Site. Please contact Geotechnical Services at (213) 847-4008 to discuss scope and scheduling of any planned or anticipated Phase II investigation(s).

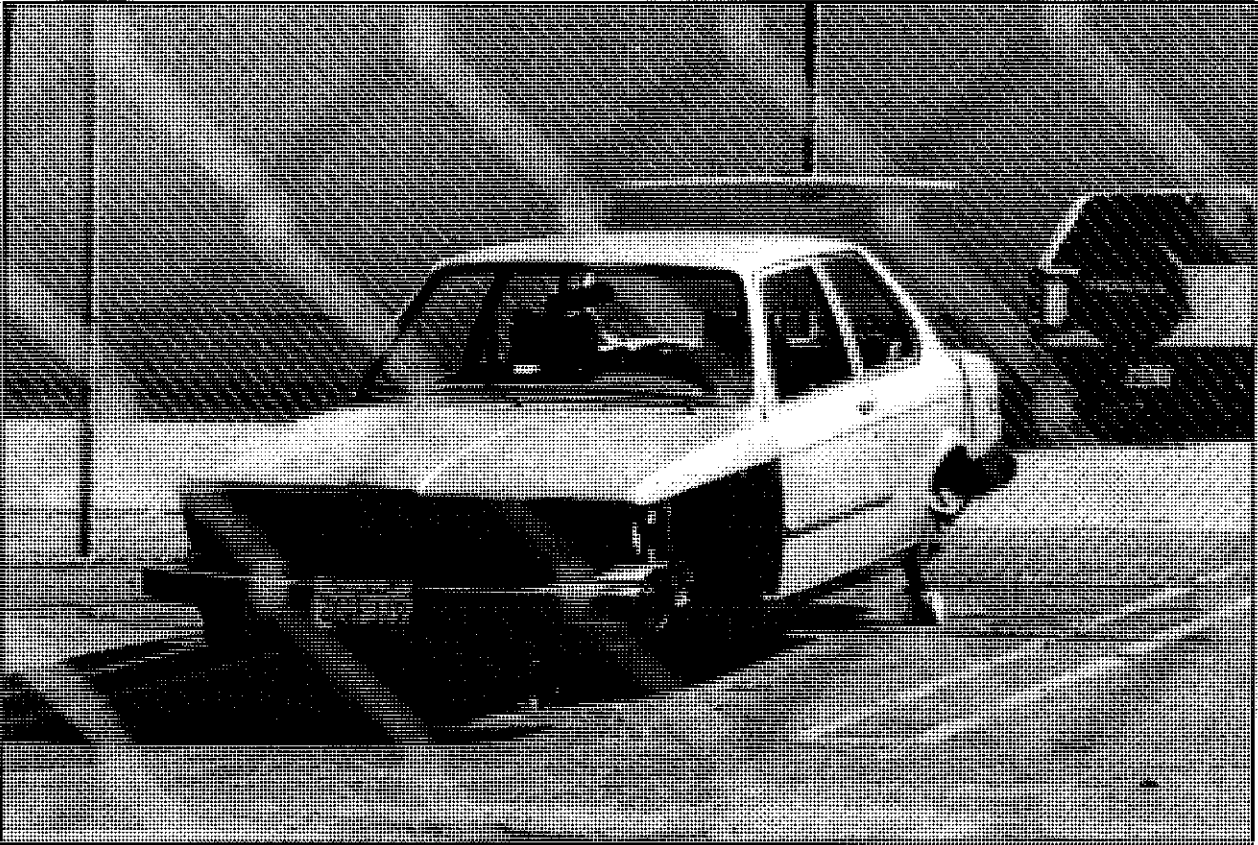
During the site visit, EG noted two issues of potential environmental concern. First, EG observed a partially dismantled automobile in the gated parking lot at 651 S. Mission Road. Automobile dismantling and repair sometimes results in releases of hazardous materials and accumulation of such releases could seriously impact soil and/or groundwater. However, as shown in Figure 7, from EG's remote perspective there is no evidence that chemical releases occurred during the dismantling of this automobile, nor does it appear that such dismantling is common practice at this location. Second, EG noted some apparent unauthorized dumping of wastes, including fragmented, weathered asphaltic concrete, at an unfenced portion of the Triangular Parcel.

FIGURE 7. Partially dismantled automobile on Triangular Parcel.

Again, in order to increase the chances of finding materials that pose a possible risk to the environment, EG urges inspection of all properties comprising the Site by a qualified environmental assessor upon receiving rights of entry.

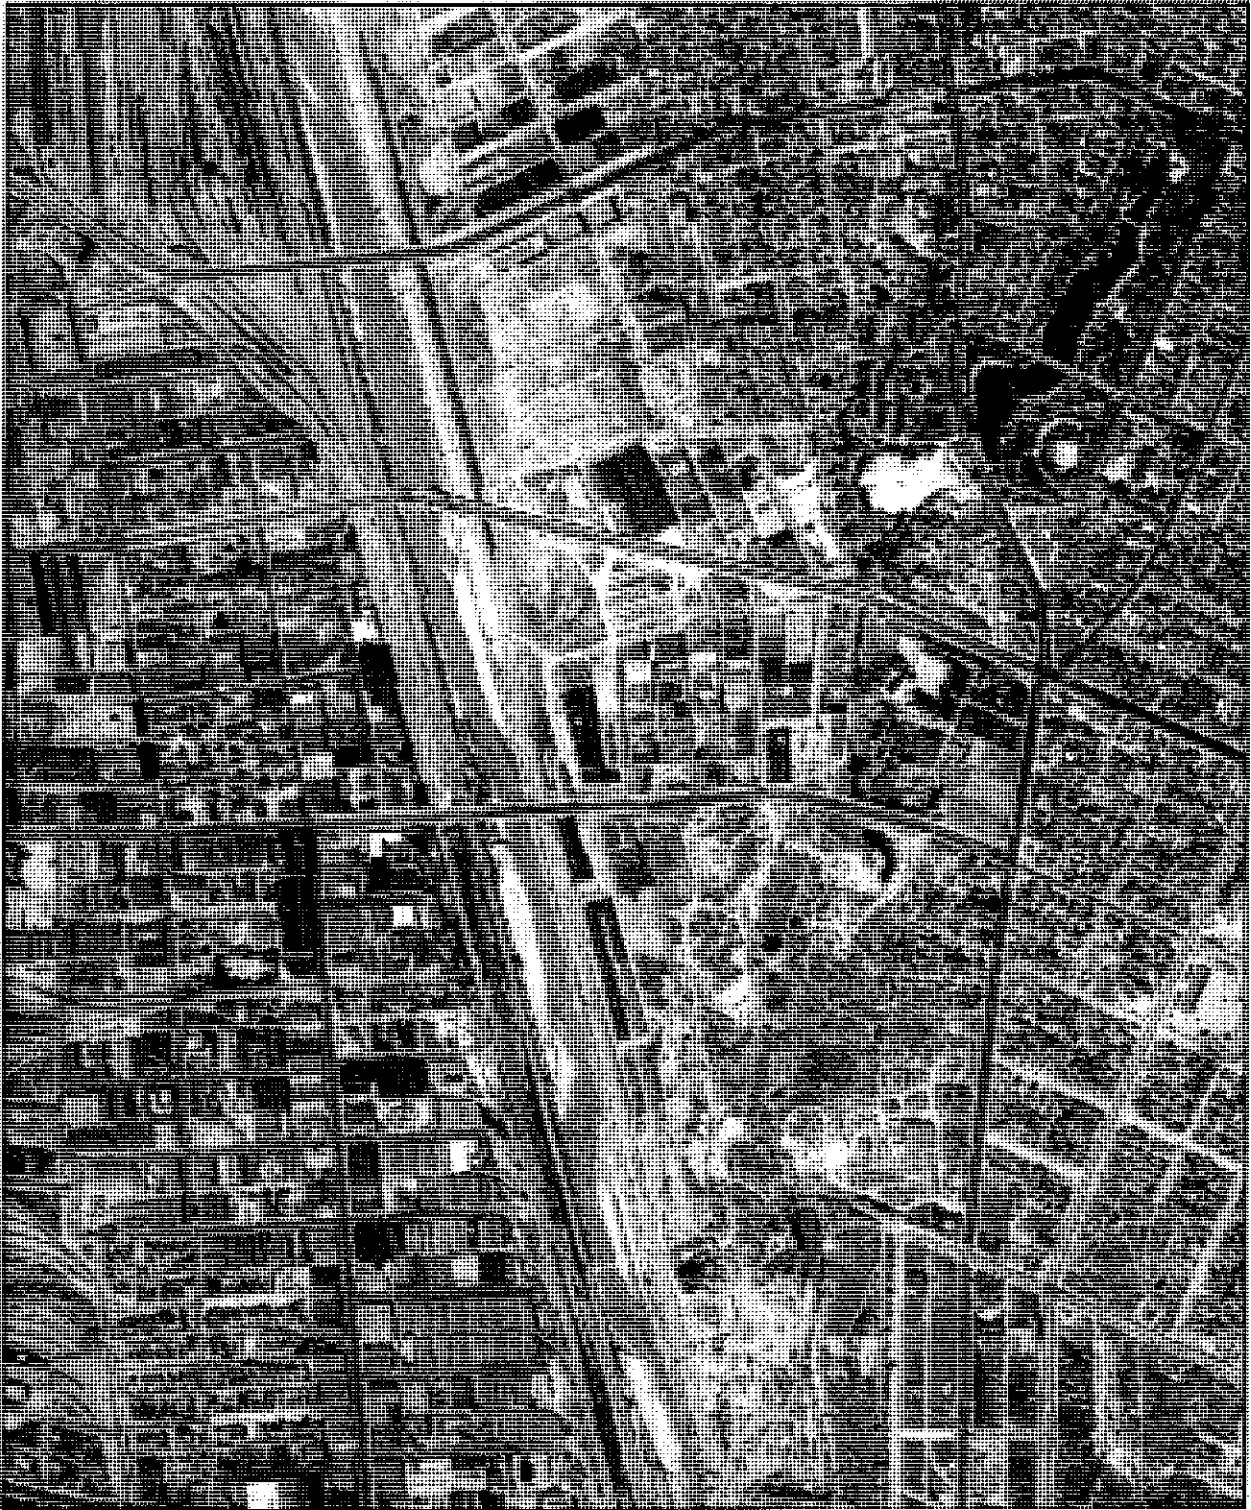
FIGURE 13. 1938 aerial photograph.

EG reviewed aerial photographs of the Site taken during 1938 and 1990. The 1938 aerial photograph shows several objects or small buildings in three series occupying the Triangular Parcel. However, due to the photographs scale and quality, EG could not identify the objects. The area immediately north of the Site appears undeveloped and the lumberyard identified from historic maps is gone. Buildings occupy all parcels along the east side of Myers Street. At the time of this photograph, Mission Road did not yet continue north directly from Jesse Street. Additional structures surround the building on Lot E, but their use is not readily apparent. Figure 13 is a copy of the 1938 photograph. The 1990 aerial photograph shows conditions essentially as they exist today.

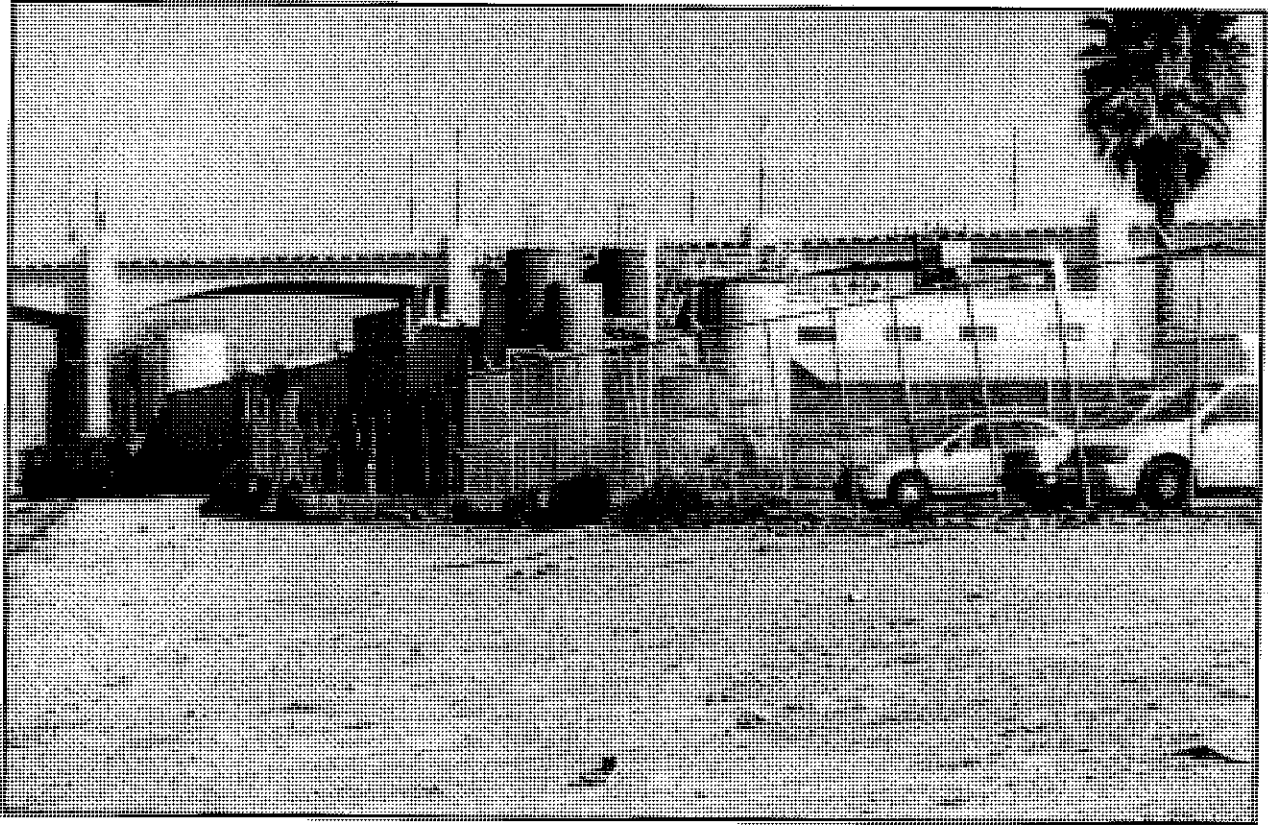
West of the Site is what remains of the railroad rights-of-way. Figures 14 and 15 show the current extent of railroad uses immediately adjacent to the Site. Additional rights-of-way also exist on the Los Angeles River's west bank. Although EG noted no particular chemical impacts, railroad uses commonly cause negative environmental impacts to soil and groundwater.

FIGURE 14. Photograph illustrating proximity of Site to the food processing plant at 633 Mission. The parking lot shown is the western limit of the Triangular Lot.

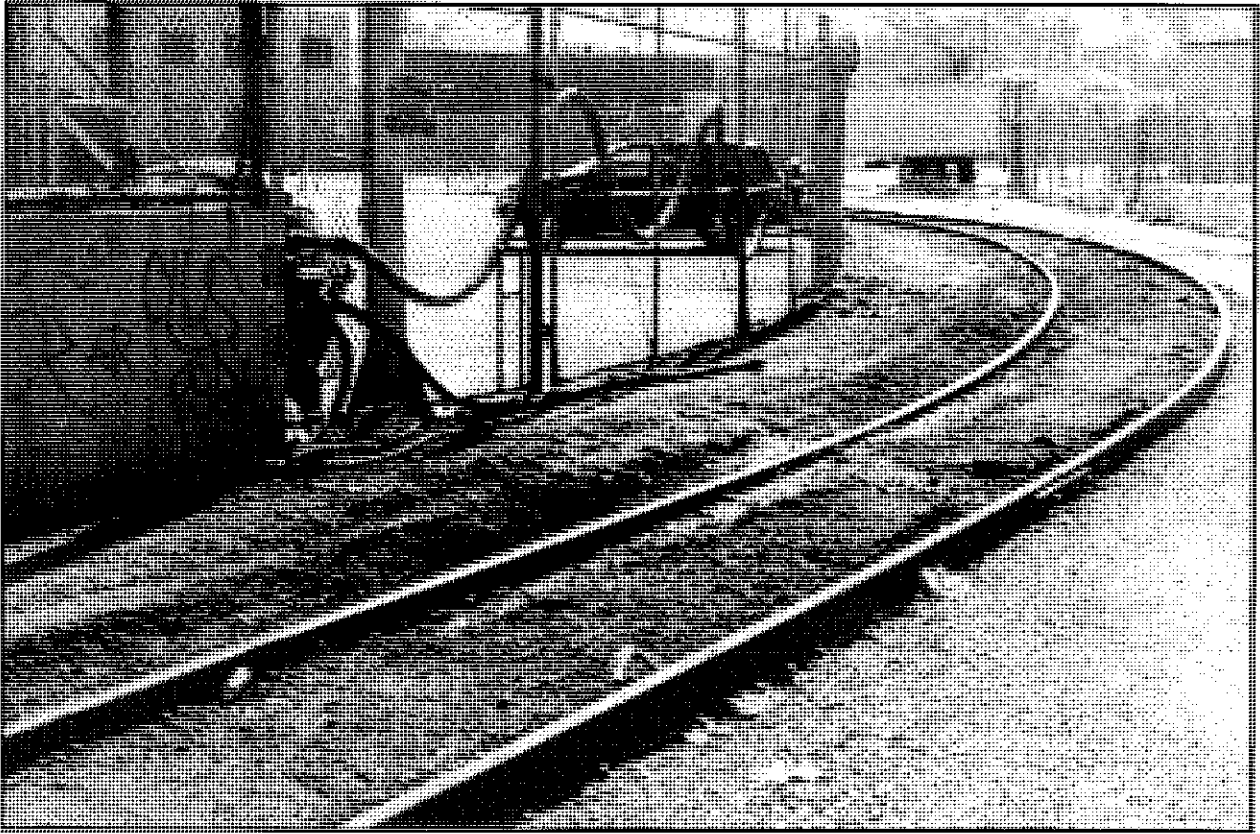
EG observed conditions that cause concern at the neighboring property northeast of the Triangular Parcel, the railroad right-of-way. This spur services many properties, including the food processing plant at 633 Mission Road. Figure 14 illustrates the food processing plant's proximity to the Site. At this location, the food processing plant apparently loads and/or unloads rail tanker cars of various liquids. Housekeeping of these liquids appeared somewhat sloppy, as EG observed staining to the soil and discolored puddles of liquids. Figure 15 shows the liquid transfer area and Figure 16 further illustrates the soil staining and relationship between the transfer area and the above ground storage tanks (ASTs). Although EG did not determine the type of liquids currently transferred at this location, this site is known to have formerly stored diesel fuel in underground storage tanks onsite as discussed further in Section 6.3, below.

FIGURE 15. Soil staining at rail tanker car loading/unloading area.

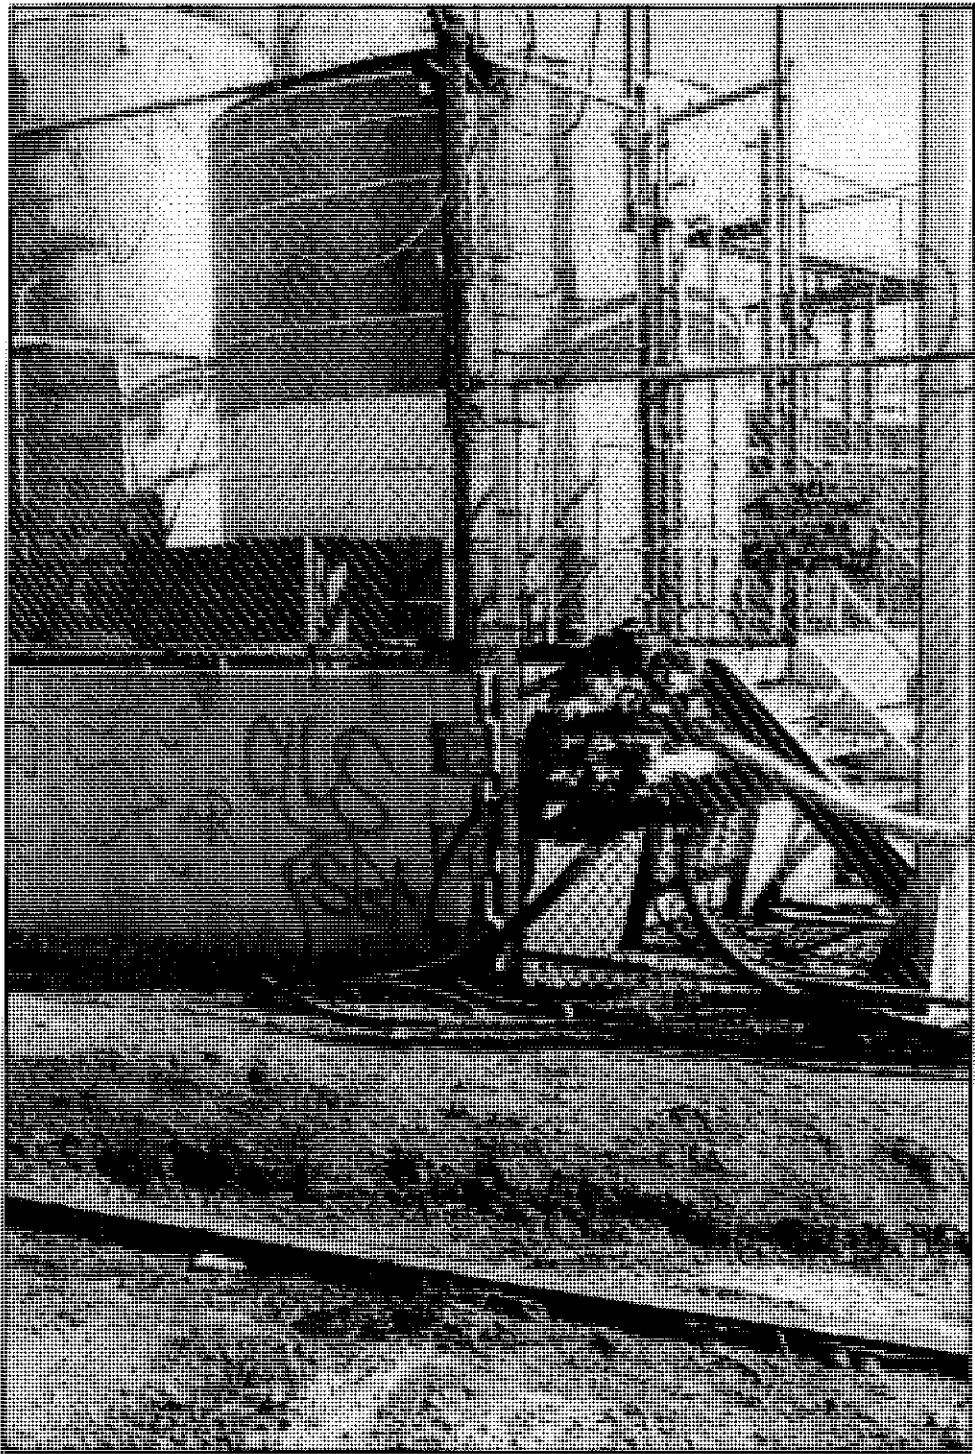
FIGURE 16. Close-up of stained soil.

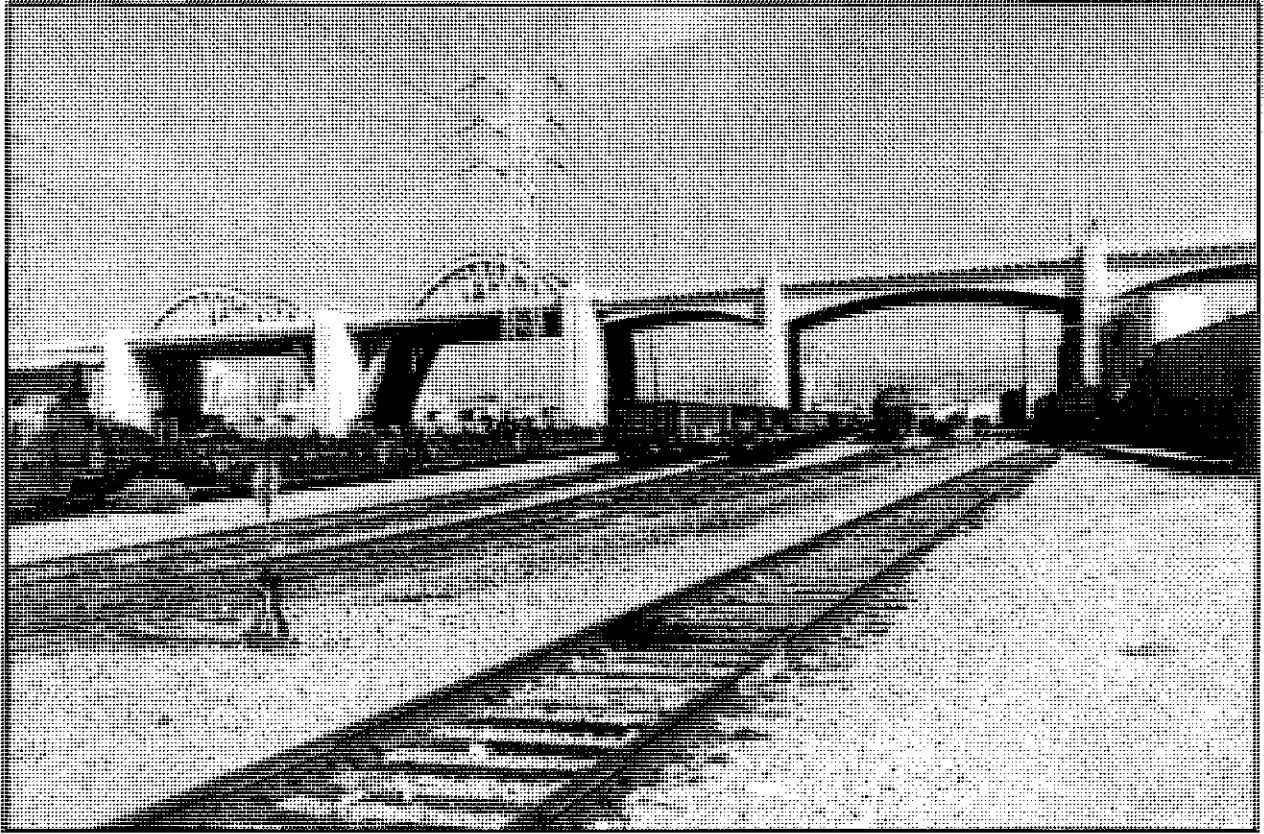
FIGURE 17. View of railroad tracks west of Site, looking north.

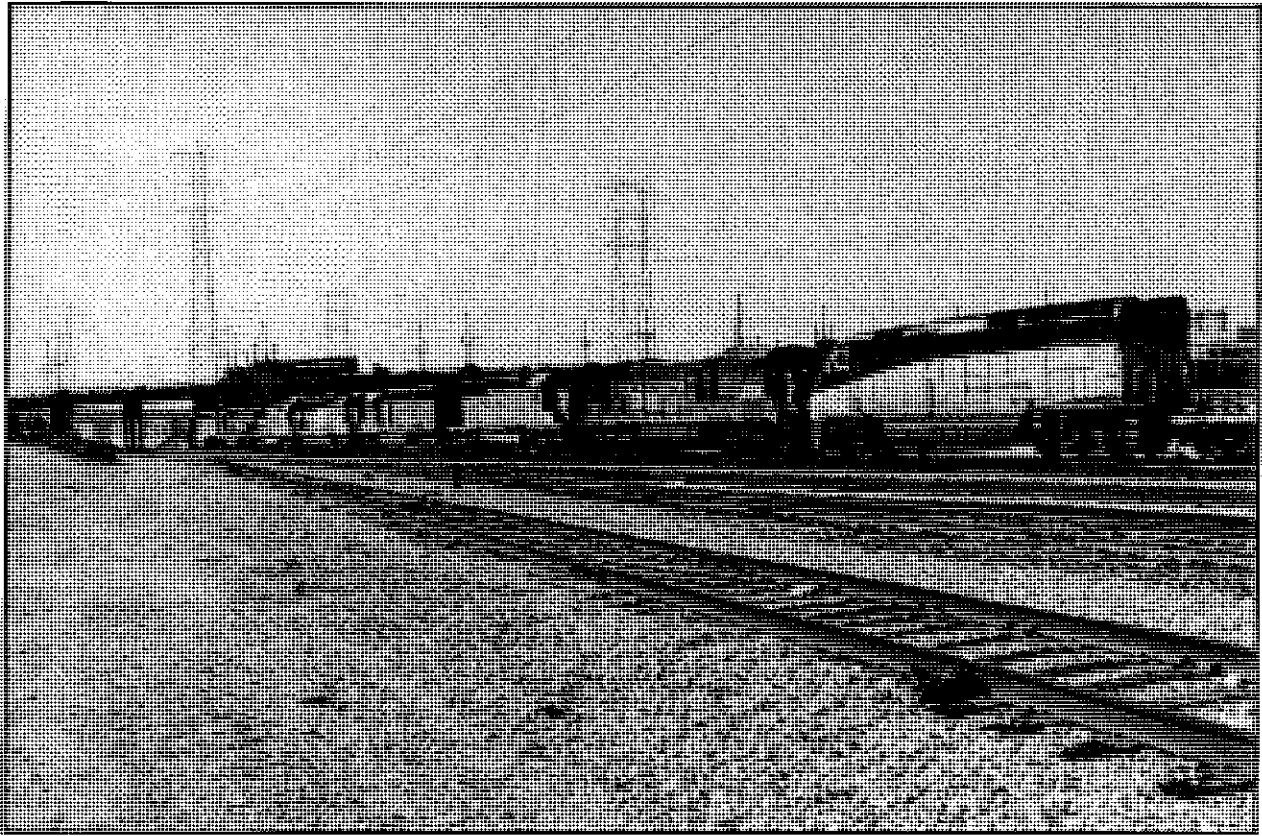
FIGURE 18. View of railroad tracks west of Site, looking south.
